2009 Anderson Island Cable Failure/Repair Summary

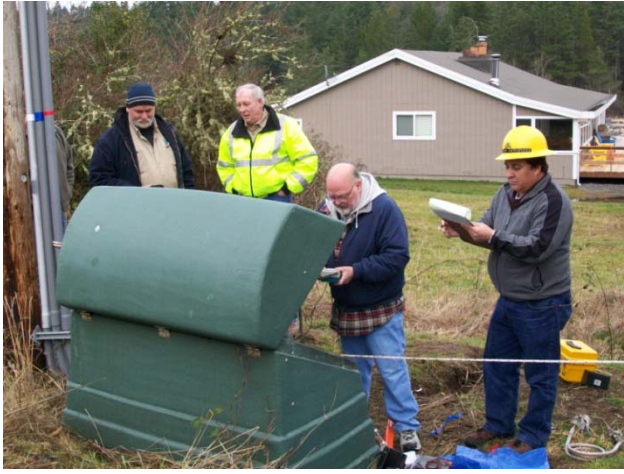
Fault locating from Anderson Island side

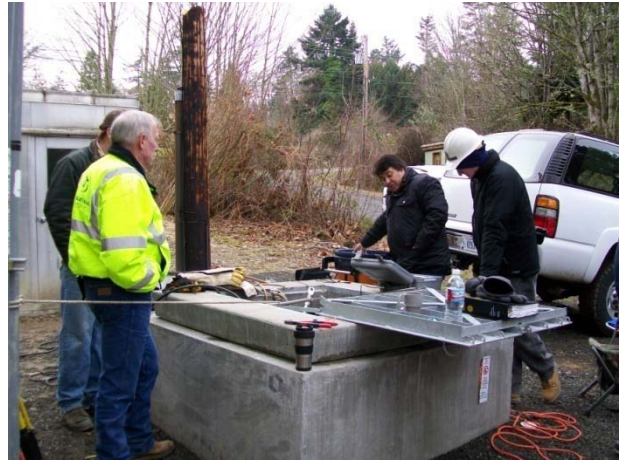
Fault locating from Luhr Beach side

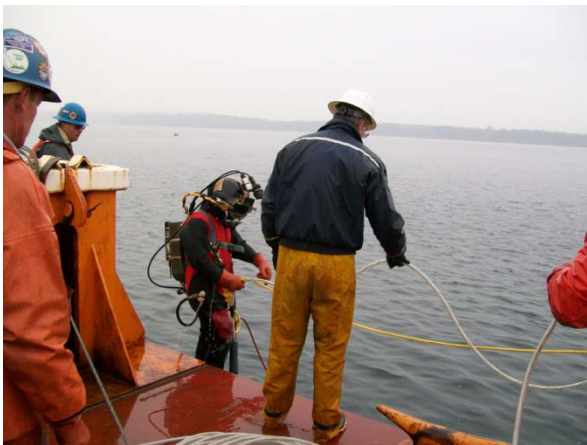
Diver entering the water to retrieve cable

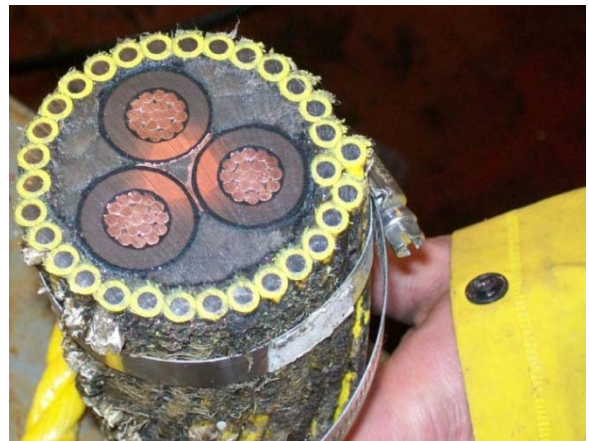
Samples of the 1976 cable were sent to both Okonite and the University of Connecticut for laboratory analysis. The samples showed evidence that the discoloration of the EPR and the corrosion of the copper tape shield were caused by biological activity. From the laboratory reports, it is unclear whether the stained or “sulfur contaminated” EPR was significantly less able to serve as an insulator required for the Tanner Electric Cooperative primary voltage. AC insulation breakdown strength was sufficient for 12,470 Volt operation, but one test showed a dissipation factor in the discolored insulation. The Okonite and University of Connecticut

After reviewing the reports and studying different failure possibilities, DHA is of the opinion that the likely causes of cable failure are combination of weakened EPR insulation (contamination), deteriorated tape shield, and a sharp bend in the cable likely caused by geological issues, such as, sand waves or earthquake/landslides during a high current fault. Marine cables have a lifetime expectancy of 30 to 50 years, so the 34-year old marine cable in question was a candidate for failure due to insulation breakdown with aging. Prior to failure, the cable insulation was injected with Novinium fluid to extend the insulation life. Laboratory results indicate sulfur insulation contamination of the insulation due to marine biological activity and that the insulation dielectric breakdown strength was slightly lower than new cable insulation, but above the minimum required for the 12,470 Volt phase to phase operating conditions. One University of Connecticut finding was that there was a high dissipation factor in the contaminated insulation that could lead to a thermal runaway under certain high current conditions. As such, general insulation failure all by itself is not the likely single cause for the cable failure.

Another factor is the deteriorated copper tape shield, which served to both relieve and contain electro-mechanical stress on the insulation and as a fault current electrical path. High fault currents and voltage doubling associated with the fault when the tree fell into the Anderson Island overhead lines may have also played a role in the failure of the initial marine cable phase conductor by damaging insulation at its weakest link by either stress or high temperature.

Marine cable (discolored insulation and copper tape shield deterioration visible)

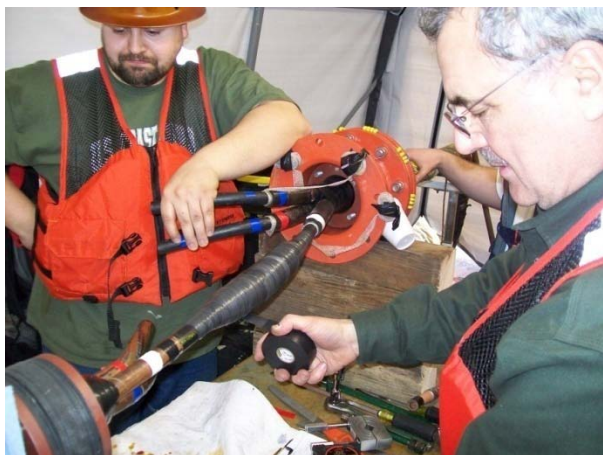
Repair of marine cable by splicing new section

The original repair effort contemplated using approximately 714 feet of spare Okonite armored marine cable. Due to the deep burial of the cable an additional 1400 feet of aluminum URD cable was installed between the points in the cable that could be retrieved by the marine contractor. As a result the repaired cable system, including the 1976 cable with contaminated insulation and deteriorated copper tape shield is a fragile system that D. Hittle & Associates, Inc. feels could last between two years and ten years.

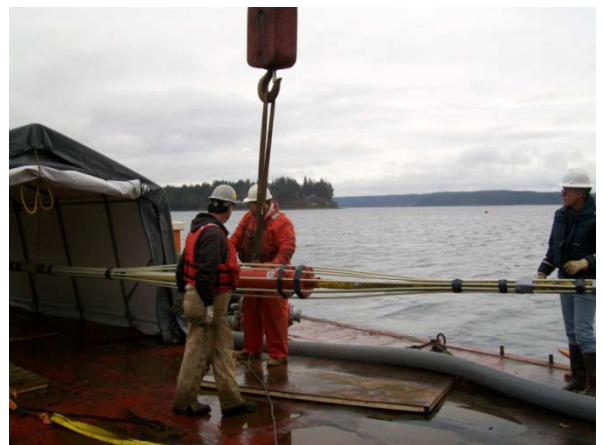
Completed splice being put in water
